SmartPhantom Prototyping Summary

Hin Tung Lau
Imperial College London
Supervisor: Prof. Kenneth Long

18th September 2019

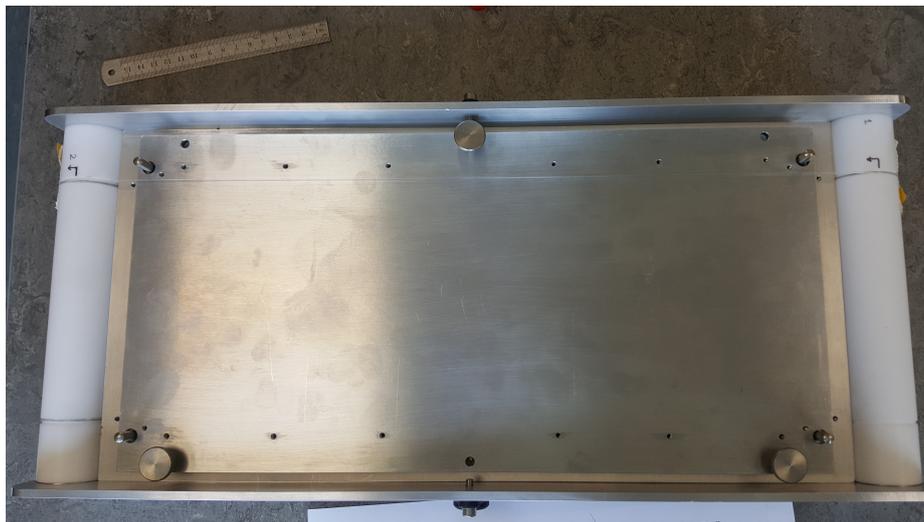
Figure 1: Assembled winding jig with two winds of fishing wire across the two lobes.

Straightness of Reference Edge	26 μm
Straightness of Fishing Wire	36.5 μm
Average Distance from Edge to Wire	37.94 mm
Maximum Deviation of Wire Straightness to Edge (over 330 mm)	0.1 mm

The maximum deviation of the wire being parallel to the reference edge was found by averaging a straight line from the reference edge to a straight line along the wire. Due to limitations of the software, the actual position of this deviation is not known, such that this maximum deviation may not be on the second lobe, but some point in the middle. The results from Metrology can be seen in Table. 1.

To fix this one could rotate one of the lobes due to the grooves being a screw thread. However, this would only resolve the situation if the maximum deviation was on the opposite edge. Since it is not known where this deviation is, it may not actually resolve the deviation issue. In addition, since two frames would be wound at once on one side, this actual deviation would likely be much less, so this deviation can be accepted.

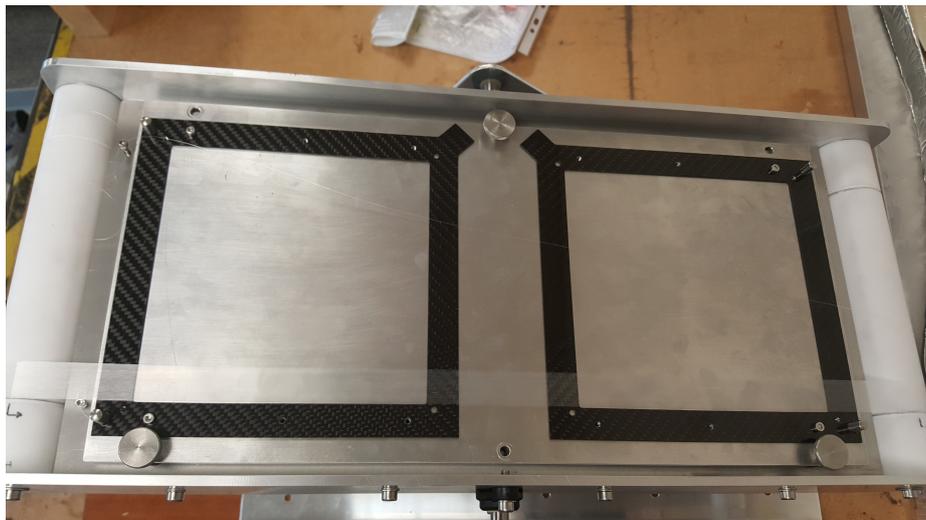
Figure 3: The result after using the fishing wire which was available. One can see the two carbon fibre frames being wound at the same time. Note that the orientations of the two frames was incorrect, and one should have been rotated by 90 degrees.

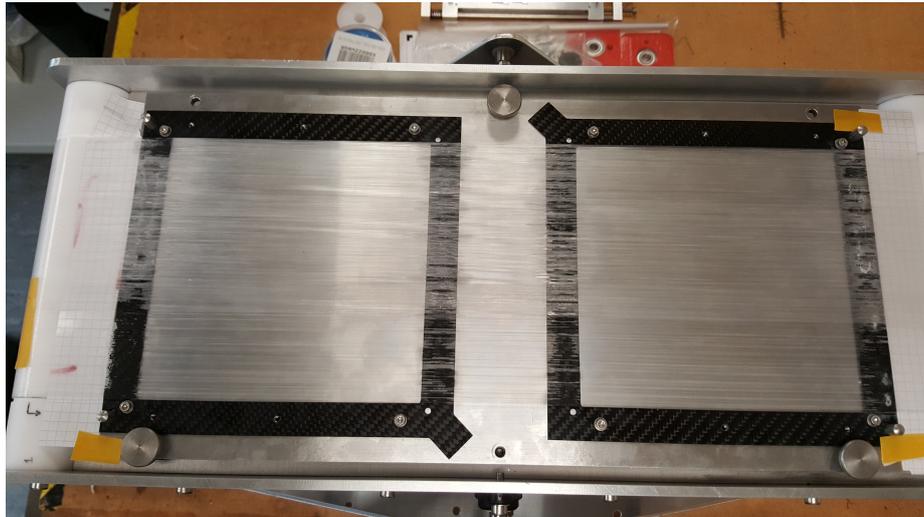
- To clean the carbon fibre frame, acetone was used.
- Grooves cut into the carbon fibre would be useful in spreading the glue on the frames.
- When applying the superglue there was a slight spreading of glue to fibres near the edges.
- Placing paper or some material beneath the frames would be helpful in ensuring the glue spread to the edge where the connection of scintillating fibres and clear fibres would be made.
- There can be issues in ensuring the glue spreads to the lower layer.
- If the frames are not raised sufficiently, then the glue only glues the two layers of wires together, but not to the frame.

Figure 6: The frames after superglue was applied. Note the presence of the glue may make it seem like the wires are criss-crossing, but the wires are straight. In addition, the sections with the double layers were harder to glue and is quite evident as with the single layer one can see the frame, which is not as clear with the double layers.

- Add grooves to the carbon fibre frame.
- Place paper beneath the frames before winding for the purposes of collecting any excess glue on the edges.
- When gluing, lower the platform (lowering the frame relative to wires) and with a sufficient nozzle have a layer of glue on the frame.
- Then raise the platform up and apply another layer of glue on top.

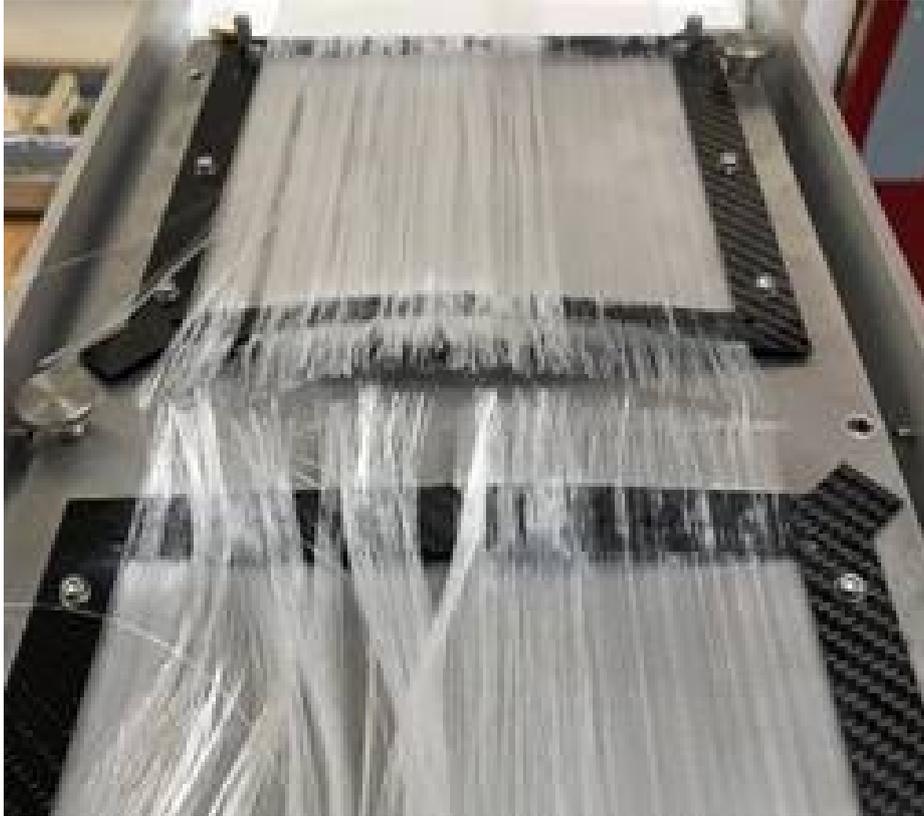
After letting the glue cure overnight, it was found that when the wires were cut, the resulting tension of the wires caused the frames to warp upwards as seen in Fig. 7. This may be an issue due to the fishing wire which is 'stretchy' and hence leads to the warping of the frame. It is unknown whether or not under the same conditions what would happen with the scintillating fibres. Most likely it would lead to the fibres snapping.

Figure 7: The result after the wires were cut where the tension in the wires caused both frames to bend.

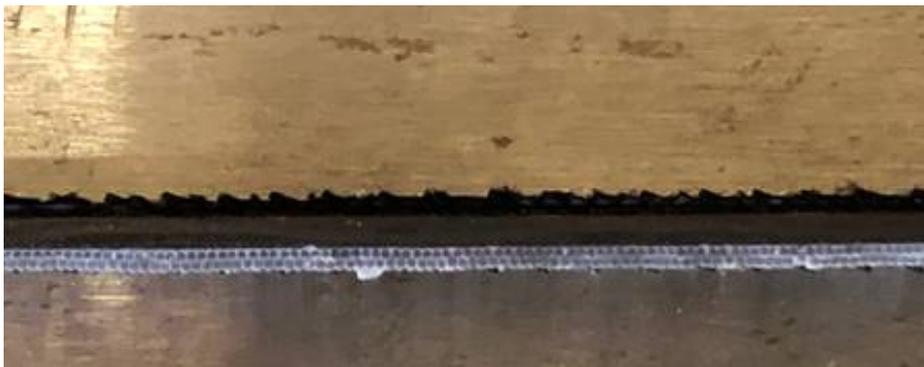
However, it should be noted that for the edge not damaged by the bending of the frames, one can see that the double layer of wires is quite nicely preserved in Fig. 8.

Figure 8: In the areas not affected by the warping we see that the double layer pattern is quite nicely preserved.

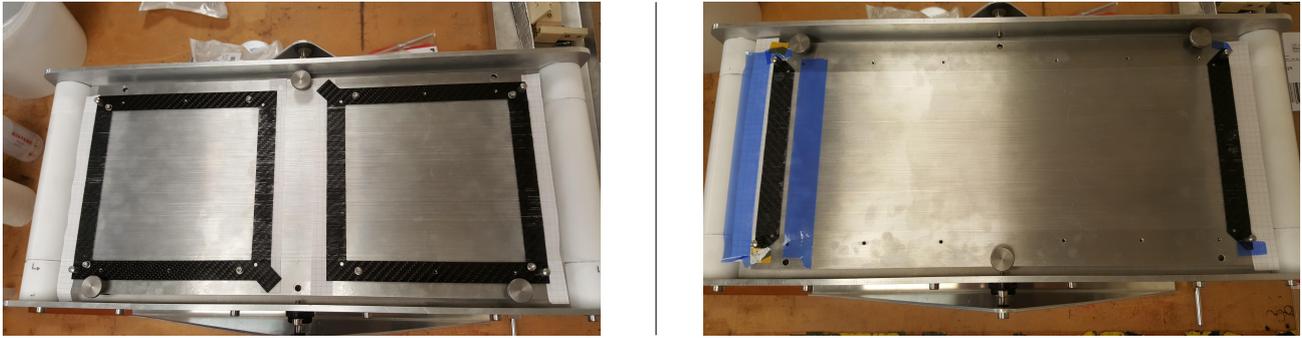
Since only one layer of superglue was used it was found that once superglue was applied, the wires for the most part locked into place. Hence an issue is that if the wires are knocked out of frame during the gluing process, it will stay knocked out.

Figure 10: Images of the second prototype after gluing. On the left we see the frames, where with a single layer it is more visually obvious of the wires being glued to the frames. On the right is the connector plates where one side has release film intended to hold the fibres in place while the other side doesn't. It did not appear to help much however.

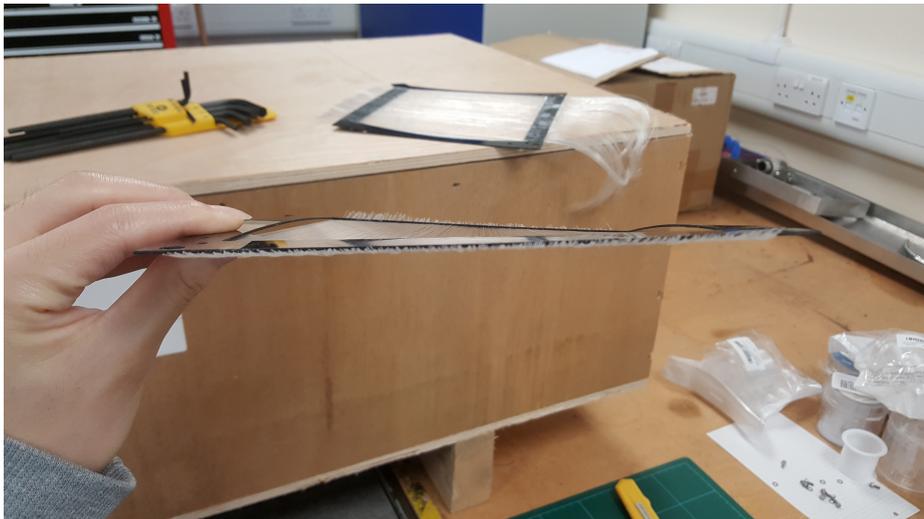
After letting the superglue cure overnight, the wires were cut, and unfortunately the tension caused the frames to bend and can be seen in Fig. 11. Though to a lesser degree compared to before due to only using a single layer. It seems apparent that there is a lower limit during the winding of the amount of tension that can be used as if it is too low then the fibres would simply pop out of the grooves.

Figure 11: The result of the frame bending after the wires were cut for the second prototype.

Another possible solution is to make the window smaller to give the edges a bit more length to spread out the tension a bit more to prevent the bending seen previously.

- Changing the frames to have a circular aperture
- Moving the lobes closer to the frames

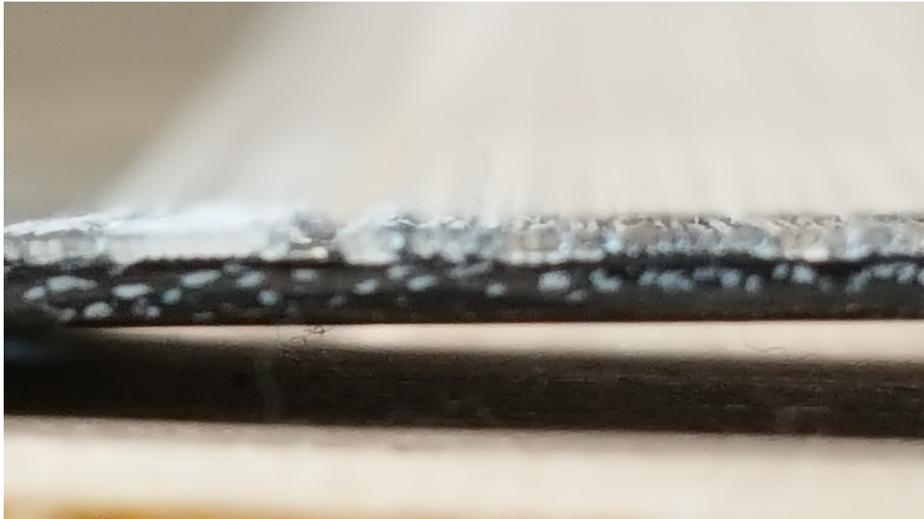
Due to the wires shifting while gluing took place, the alignment was also an issue where the clear fibres would not line up to the scintillating fibres and can be seen in Fig. 12.

Figure 12: An image of one of the ends used for alignment. There are some noticeable gaps where during the gluing process some of the fibres have shifted to group and stick together.

- Use more tension during Winding
 - If the wires were wound with a lot of tension then wires do not move during gluing, but this leads to problems with the tension.
 - Or in the case of real fibres, may lead to fibres snapping.
- Move lobes closer to the frames
 - If the frames were adjacent to the lobes, then when gluing there should be very little movement on the alignment edge.

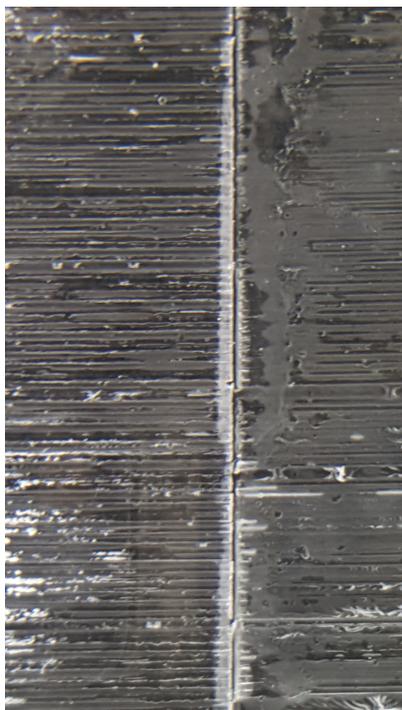
With the prototype, when attempting to do the alignment it appeared a small gap was visible between the connector plate wires and the frame wires which can be observed in Fig. 14. This may be an issue to do with the edges of the wires not being polished. Although the edges were attempted to be cut to be flush to the edge as much as possible, the small gap is still visible.

Figure 14: A close up of the connection being made between the frames and connector tab. In the case of the prototype it appears there is a gap which may be an issue of the fishing wire not being polished on the edges.

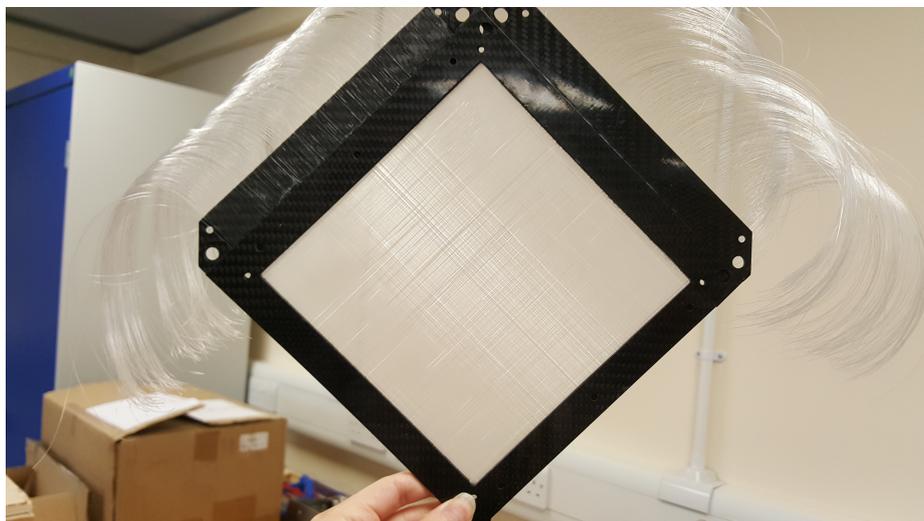
Furthermore, when the frames were put together to form one station, the bend is still present. It may be possible that having multiple stations in succession could help mitigate this. The final second prototype can be seen in Fig. 15.

Figure 15: A second prototype station with the two frames glued together with the wires oriented 90 degrees with respect to each other, and each frame is aligned to a connector tab.
