Progress on the evaluation of the Gabor lens

CCAP meeting 6th November 2018

Aim: RBE facility at Imperial – first part of beam line

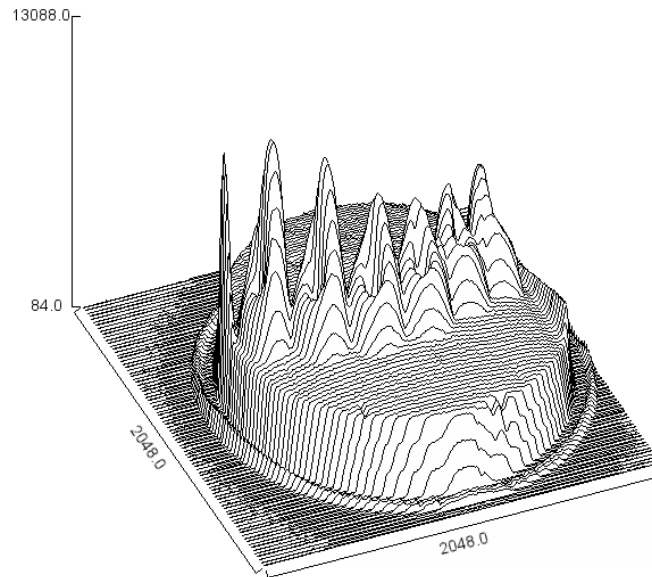
Latest results from Beam measurements

– deflection ratio (x,y) is dependent of (radius)

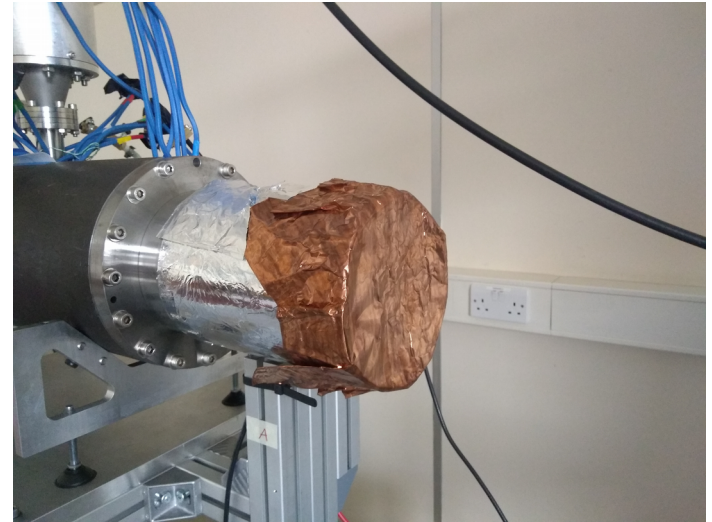
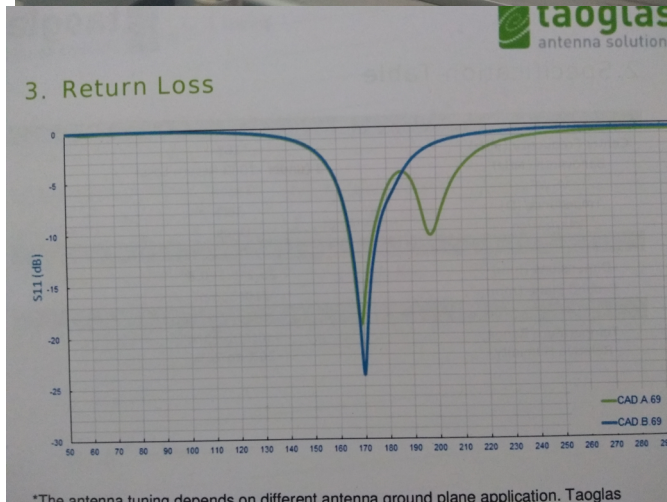
RF investigations - Moritz Sebald

- two types of antenna pairs have been characterized are used.

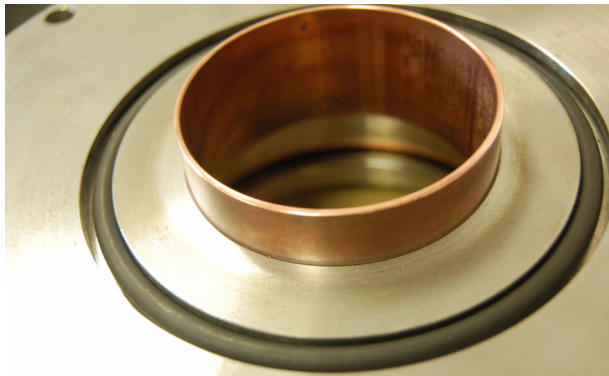
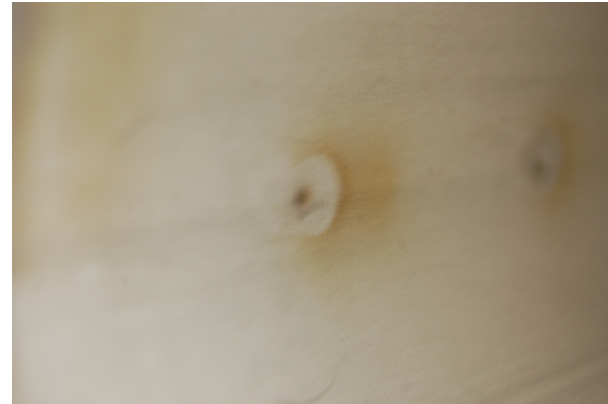
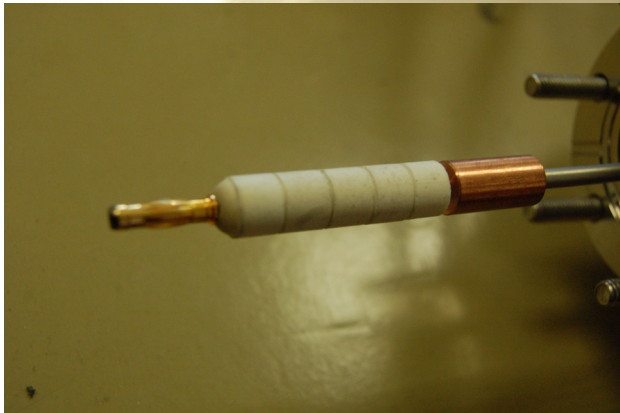
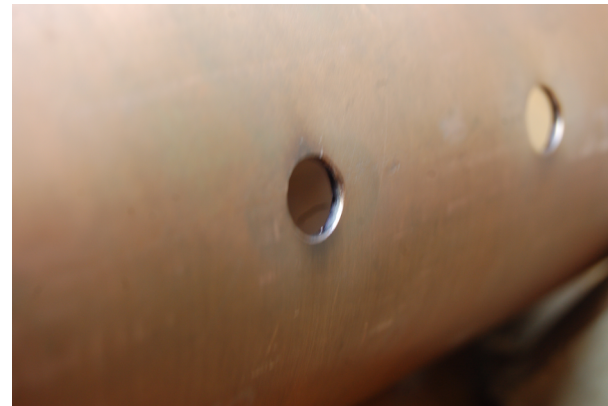
- Disassemble Lens and review internals **Done**

Main issues identified, all connected with dislocated discharges at endlanges, pumping holes and one pint at feedthrough. All will be part of first changes
