SmartPhantom Prototyping Summary

Hin Tung Lau
Imperial College London
Supervisor: Prof. Kenneth Long

18th September 2019

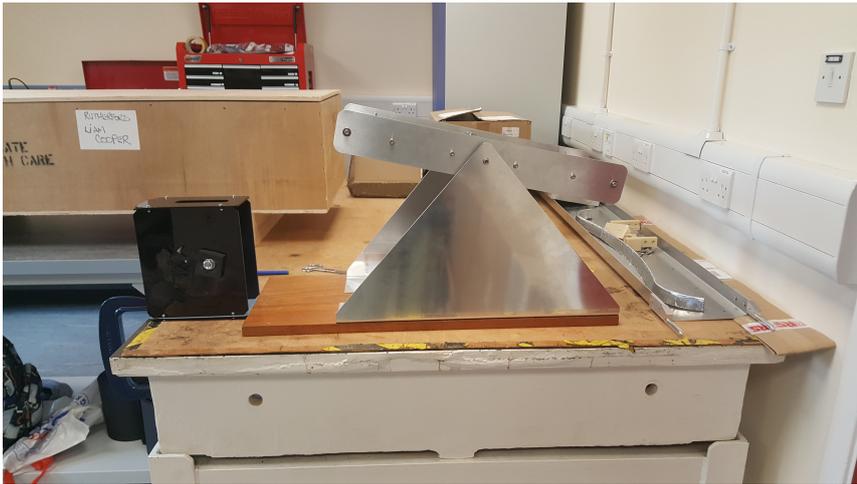
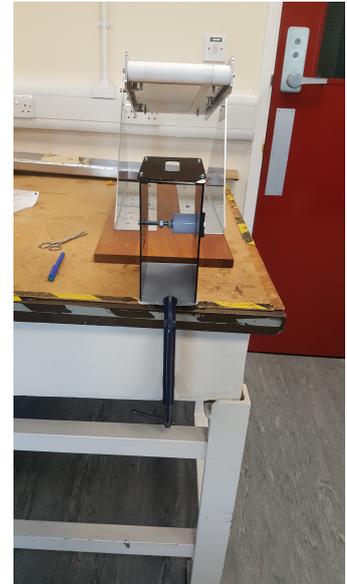
A tensioning solution was found for the winding fibres, though with the clear and scintillating fibres, it may just be a simple matter of a screw and washer pressed against the spool. Images of the setup at RAL can be seen in Fig. 2.

Figure 2: The setup for the winding jig at RAL. On the left one can see the winding jig affixed to the outer frame atop a wooden plank. On the right one can see the tensioning solution, which consists of washers pushing against the spool of fishing wire.

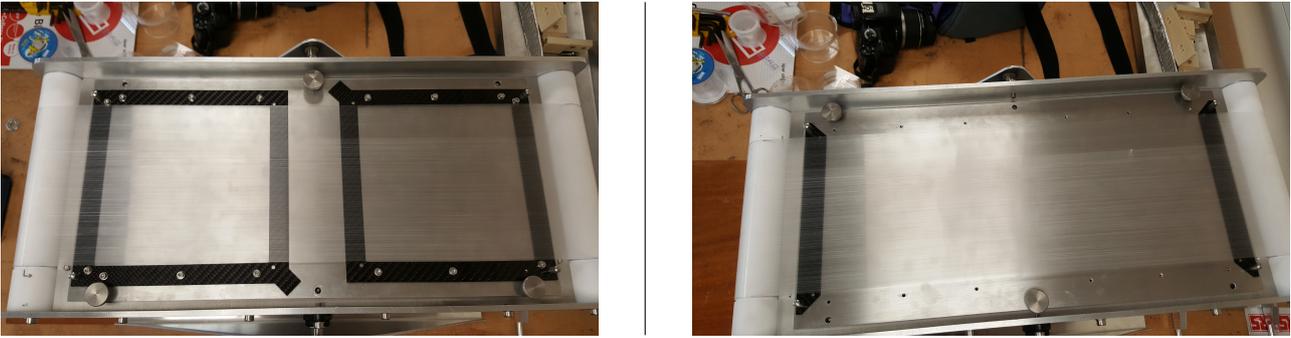
The previous observations were noticed where the greatest difficulty was with the starting groove. The efficiency of winding increased as more winds were made. Some of the winding was done with gloves to test the subdued tactile feedback and it proved to not be a major issue. Due to the limited amount of fishing wire in a given spool, the wires were tied together, this can be seen in Fig. 4.

Figure 4: Images of the result after winding one layer of wire across the winding jig. On the left is one side of the winding jig with the frames in the correct orientation with respect to each other. On the right is the other side of the winding jig with the connector plates. Note the knot in from connecting two separate spools of fishing wire.

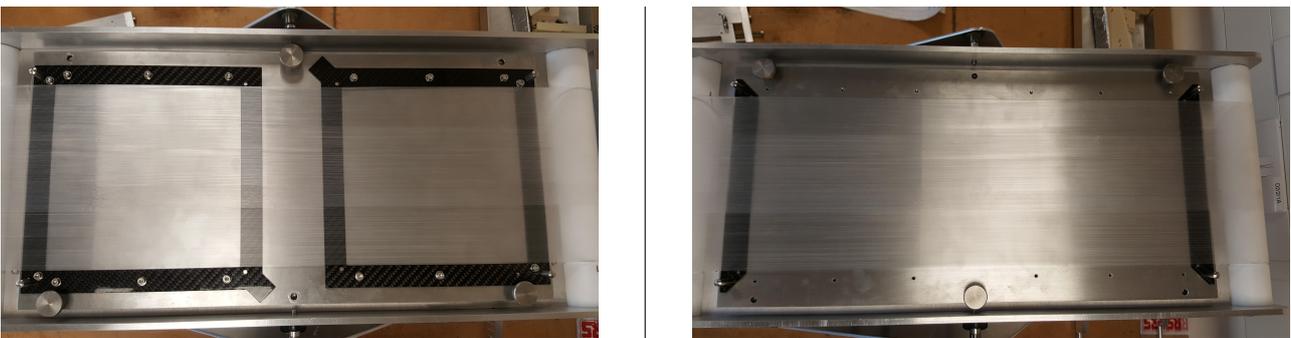
The rest of the fishing wire was used to try to complete as much of the second layer as was possible. No additional observations were noted. At the very end, to keep the fishing line taut, the fishing wire was wound around a screw. For scintillating fibres it may be possible to keep it on the spool, as it should still retain the tension. Then for the next set of rotations, the scintillating/clear fibre would just need to be held in place with a large headed screw and screwed down to keep in place. The final result of winding for the first prototype can be seen in Fig. 5.

Figure 5: Images of the result after winding two layer of wire across the winding jig, though not enough fishing wire was available so the second layer remains incomplete. On the left is one side of the winding jig with the frames. On the right is the other side of the winding jig with the connector plates.

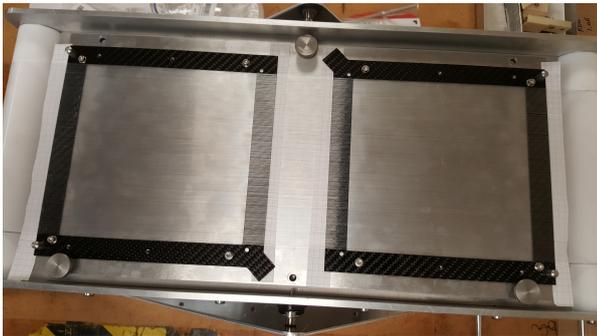
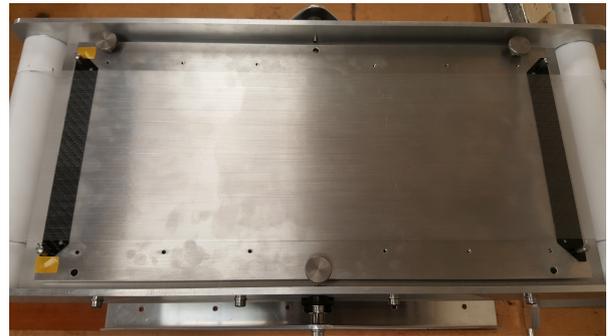
Figure 9: Second prototype with one layer of wire wound. On the left is the side with the frames, note the paper placed underneath the frames beforehand for the gluing. On the right is the connector plates, in this case the paper is missing as it was found the connector plates were loose and the paper would be placed afterwards before the gluing.

If one layer still prove to be an issue, then either a thicker frame would need to be used, or an additional frame would need to be placed on top of the wires to keep the frames from warping to the tension or some other solution would need to be used with the result of winding seen in Fig. 9.

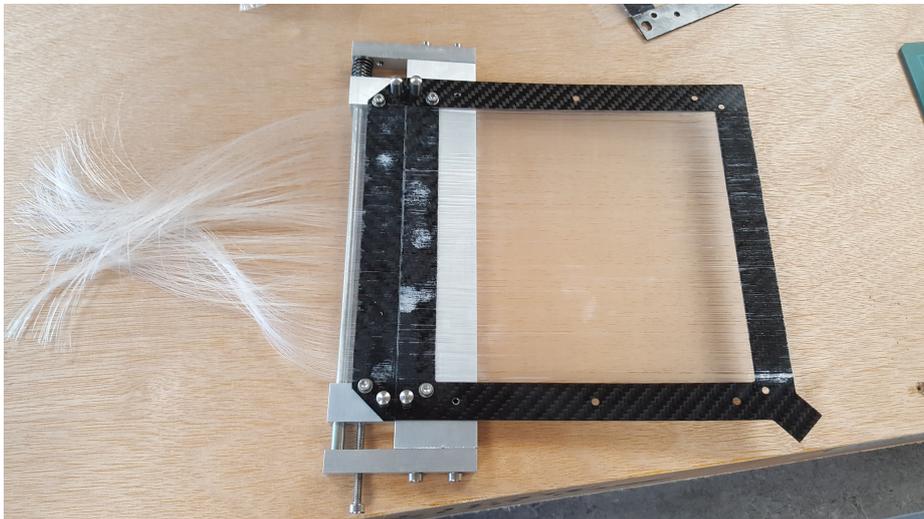
Figure 13: The alignment concept of aligning the connector plate wires with the frame wires. The connector tab position can be moved with respect to the frame through the screw rod on the bottom.
