# SmartPhantom: Prototyping Log and Summary

Hin Tung Lau  
Imperial College London  
Supervisor: Prof. Kenneth Long

8th October 2019

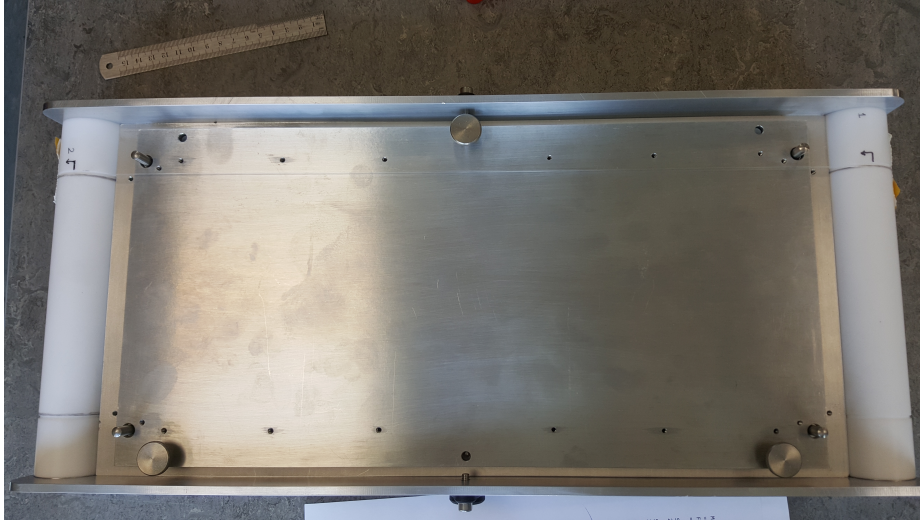
Figure 1: Assembled winding jig with two winds of fishing wire across the two lobes.

The parts needed for assembly of the winding jig arrived at Rutherford Appleton Laboratories (RAL) on 15/08/2019. The winding jig was assembled on 20/08/2019 as specified in the schematics. Fishing wire was wound across a couple of grooves in order to check the straightness along the two lobes. This can be seen in Fig. 1. This was brought to the Metrology department to check using the SmartScope, where the straightness of the fishing wire was compared against a reference edge. The results from Metrology show that over 330 mm, there would be a maximum deviation from being parallel to the reference edge of 0.1 mm. The position of this maximum deviation is not known, but since two frames would be wound across one side of the winding jig, this is an acceptable result.

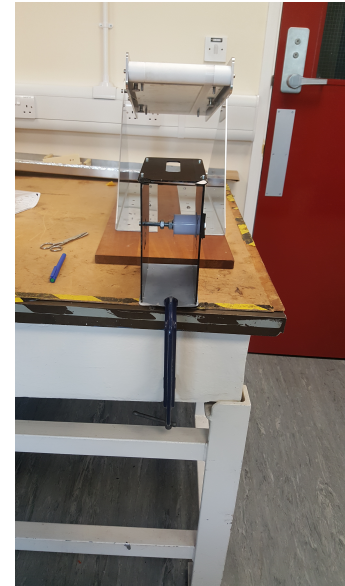
Figure 2: The setup for the winding jig at RAL. On the left one can see the winding jig affixed to the outer frame atop a wooden plank. On the right one can see the tensioning solution, which consists of washers pushing against the spool of fishing wire.

A tensioning solution was found for the winding fibres, though with the clear and scintillating fibres, it may just be a simple matter of a screw and washer pressed against the spool. Images of the setup at RAL can be seen in Fig. 2.

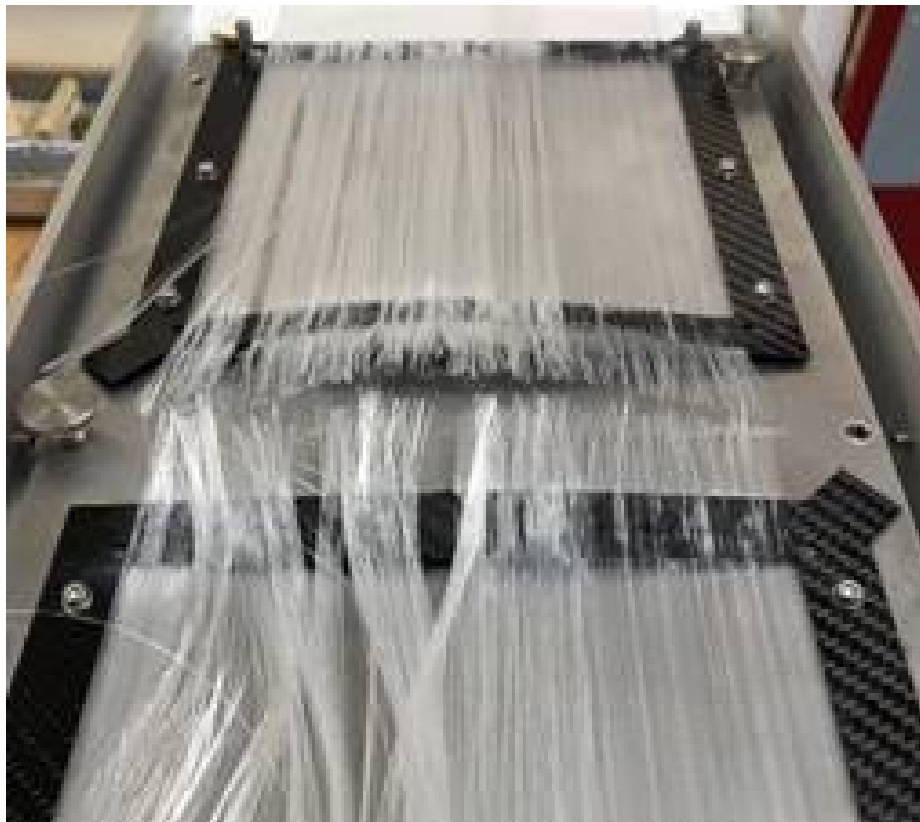
Figure 7: The result after the wires were cut where the tension in the wires caused both frames to bend.

After letting the glue cure overnight, it was found that when the wires were cut, the resulting tension of the wires caused the frames to warp upwards as seen in Fig. 7. This may be an issue due to the fishing wire which is 'stretchy' and hence leads to the warping of the frame. It is unknown whether or not under the same conditions what would happen with the scintillating fibres. Most likely it would lead to the fibres snapping.

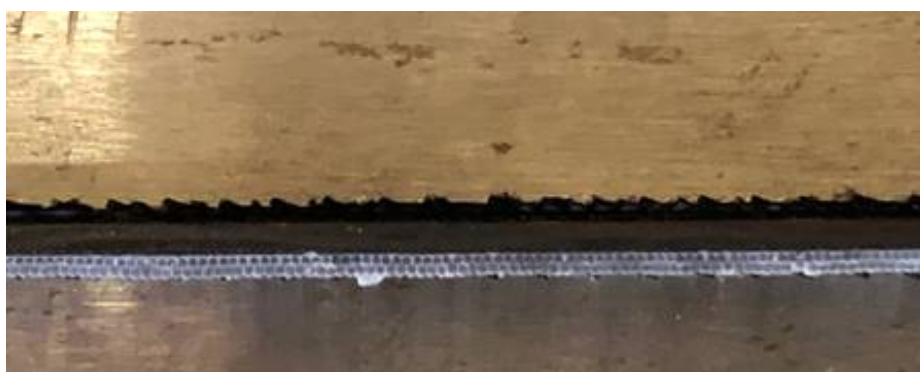
Figure 8: In the areas not affected by the warping we see that the double layer pattern is quite nicely preserved.

However, it should be noted that for the edge not damaged by the bending of the frames, one can see that the double layer of wires is quite nicely preserved in Fig. 8.

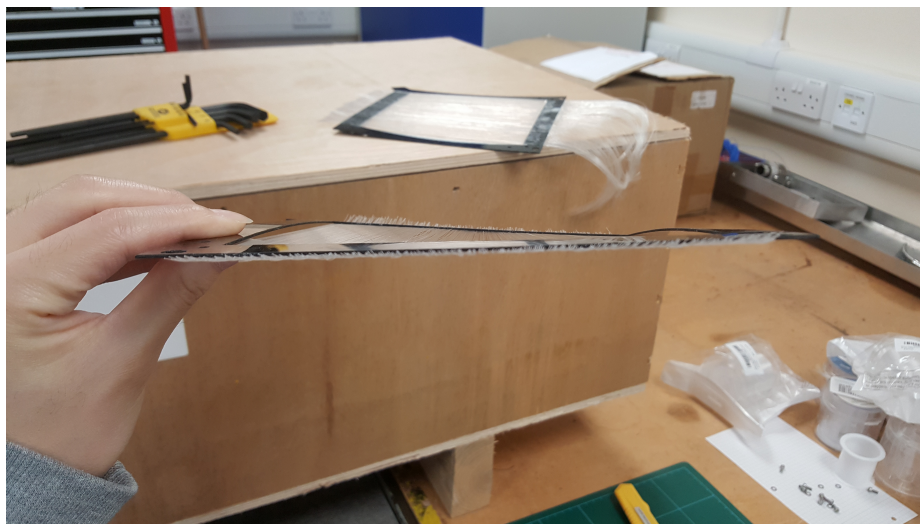
Figure 11: The result of the frame bending after the wires were cut for the second prototype.

After letting the superglue cure overnight, the wires were cut, and unfortunately the tension caused the frames to bend and can be seen in Fig. 11. Though to a lesser degree compared to before due to only using a single layer. It seems apparent that there is a lower limit during the winding of the amount of tension that can be used as if it is too low then the fibres would simply pop out of the grooves.

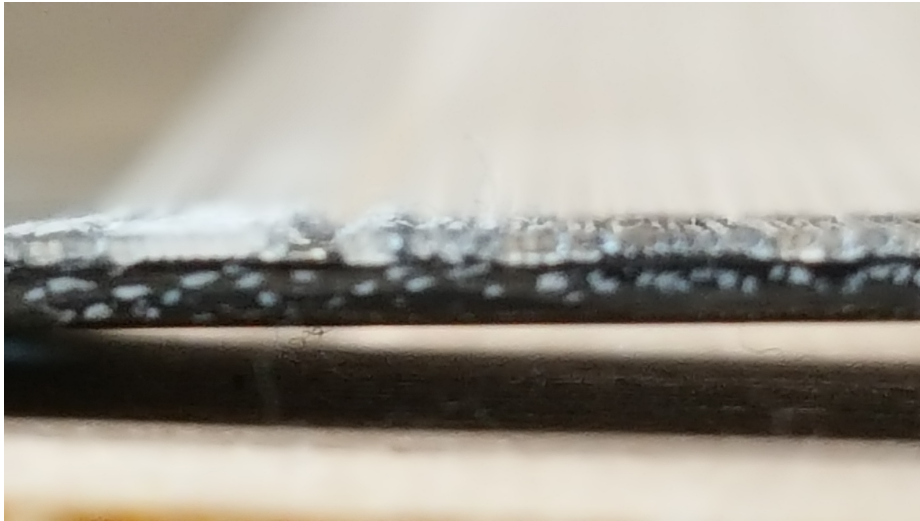
Figure 12: An image of one of the ends used for alignment. There are some noticeable gaps where during the gluing process some of the fibres have shifted to group and stick together.

Due to the wires shifting while gluing took place, the alignment was also an issue where the clear fibres would not line up to the scintillating fibres and can be seen in Fig. 12.

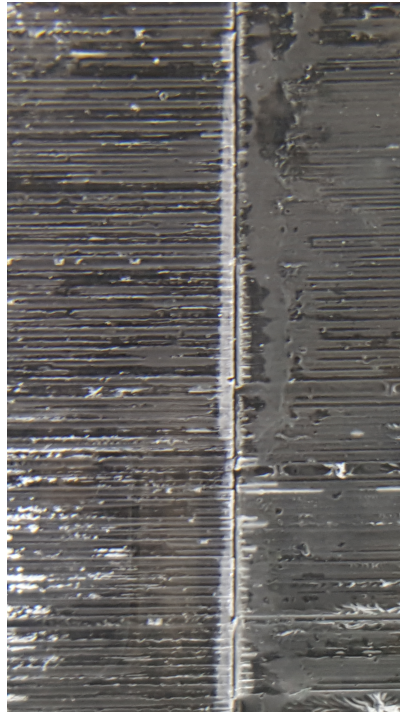
Figure 14: A close up of the connection being made between the frames and connector tab. In the case of the prototype it appears there is a gap which may be an issue of the fishing wire not being polished on the edges.

With the prototype, when attempting to do the alignment it appeared a small gap was visible between the connector plate wires and the frame wires which can be observed in Fig. 14. This may be an issue to do with the edges of the wires not being polished. Although the edges were attempted to be cut to be flush to the edge as much as possible, the small gap is still visible.

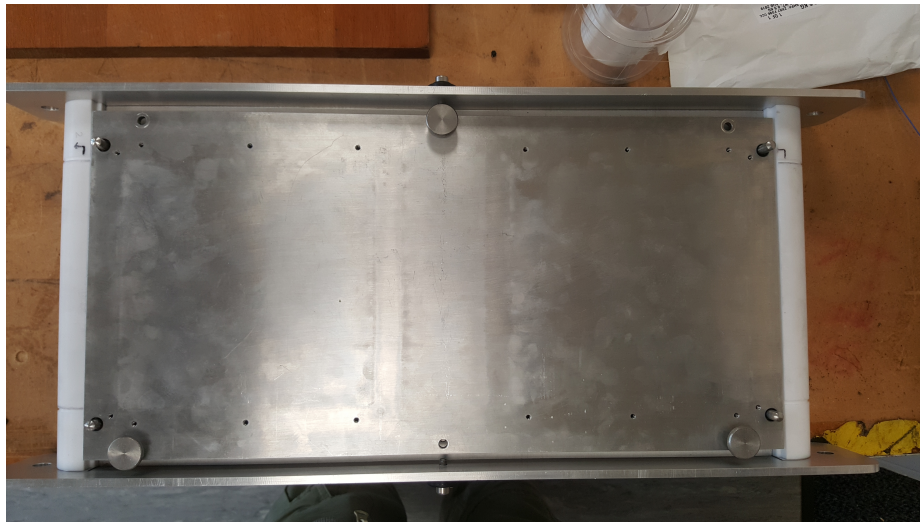
Figure 17: Modifications were made to the winding jig, where the lobes were cut in half length wise and positioned adjacent to the platen to keep the wires from moving when gluing in order to help with the alignment.

The modified carbon fibre frames to solve the tension issue with the new smaller circular aperture can be seen in Fig. 16. In addition, the winding jig was also modified to resolve the alignment issues where the lobes were cut in half and placed adjacent to the platen as can be seen in Fig. 17
